## Outdoor Pitch Risk Assessment

Updated: 13<sup>th</sup> September 2015

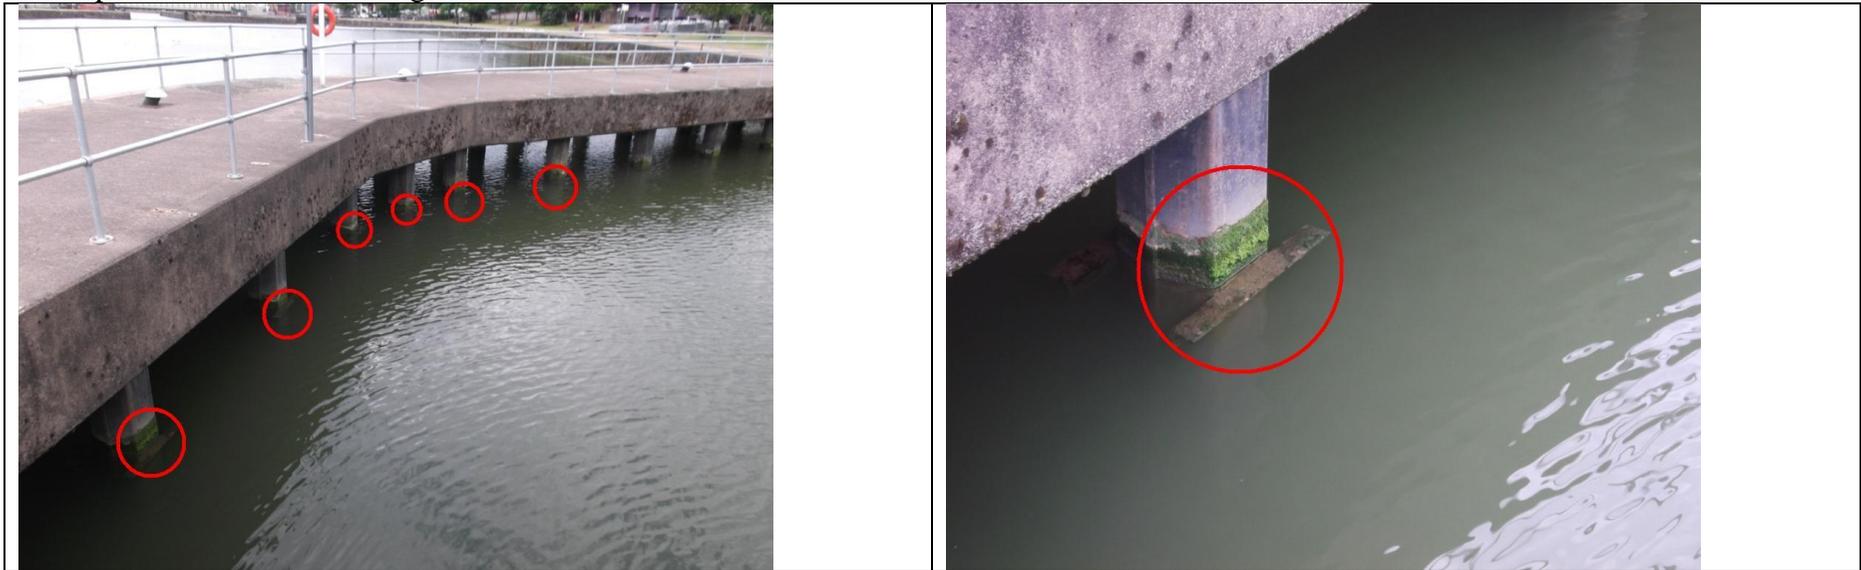
There is a barrier that separates the outdoor pitch area and the rest of the Cumberland basin. To pass from one to the other you must pass under the barrier. The columns holding the walkway have metal sections protruding out at water level. These present a hazard to composite boats. The barrier presents an additional risk at high tides where the gap underneath will be reduced. Paddlers should use good judgement as to whether it is safe to pass under the barrier at given water levels.

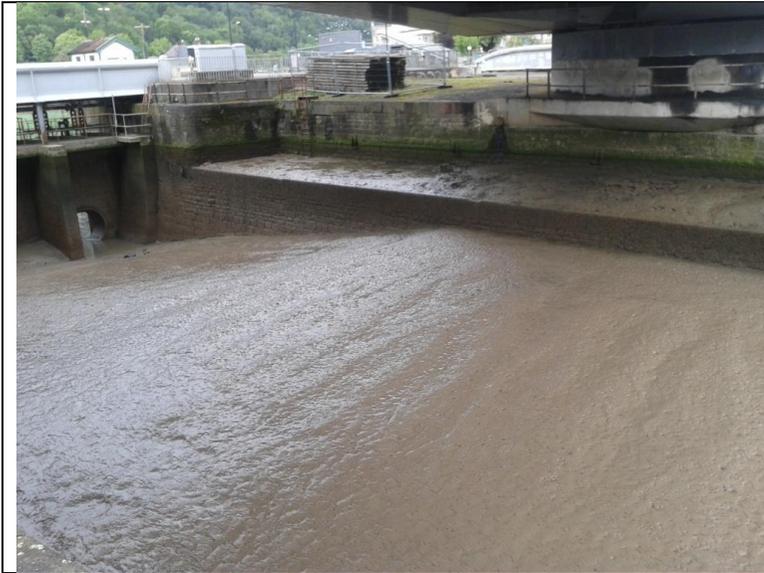
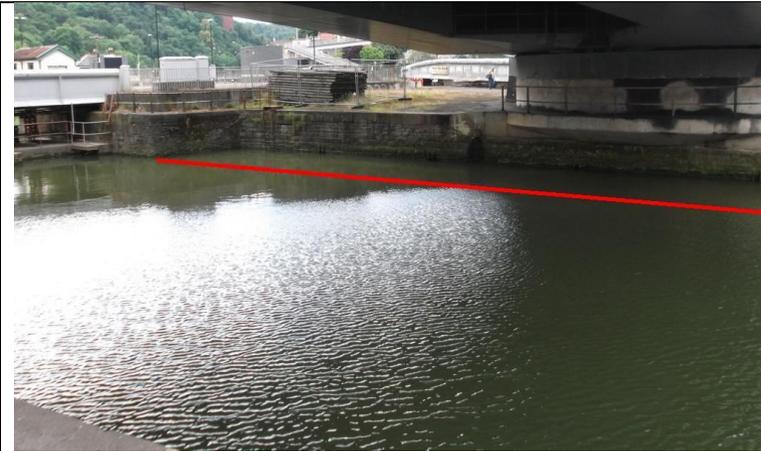
There is an underwater shelf on one side of the pitch. The access ramp sits on this shelf, although the shelf extends further along the pitch and also slightly further into the pitch than the edge of the pontoon. The water above the shelf is only approximately 30cm. Players should be aware of this when paddling above it (particularly dip turning). Play above the shelf should be avoided, particularly where players may go upside down (i.e. though a successful hand tackle). In addition to the risk presented by the shallow water, there may be debris on the shelf.

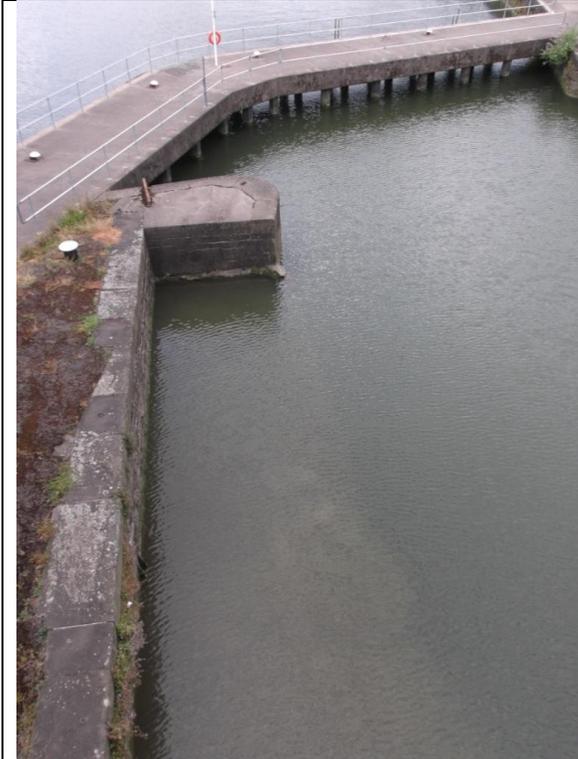
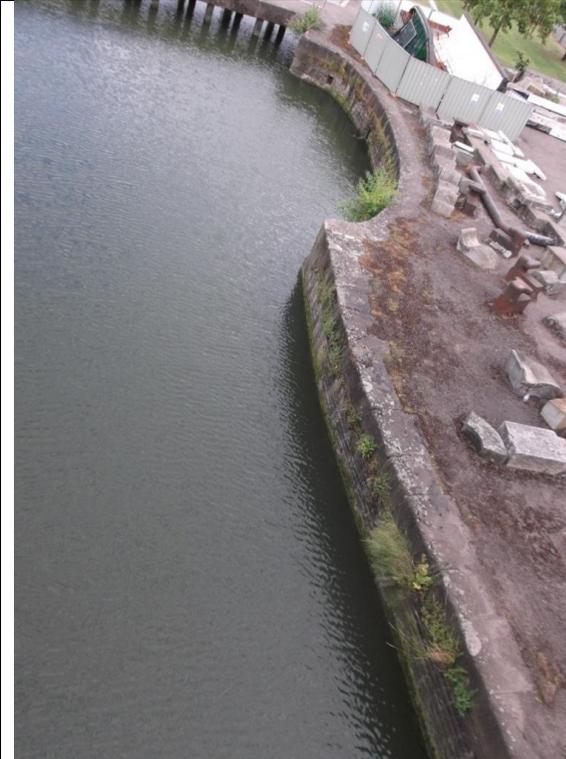
The sides of the basin where the pitch is are not straight. Care should be taken when refereeing not to fall in. The ground is also rough and so poses a risk of tripping.

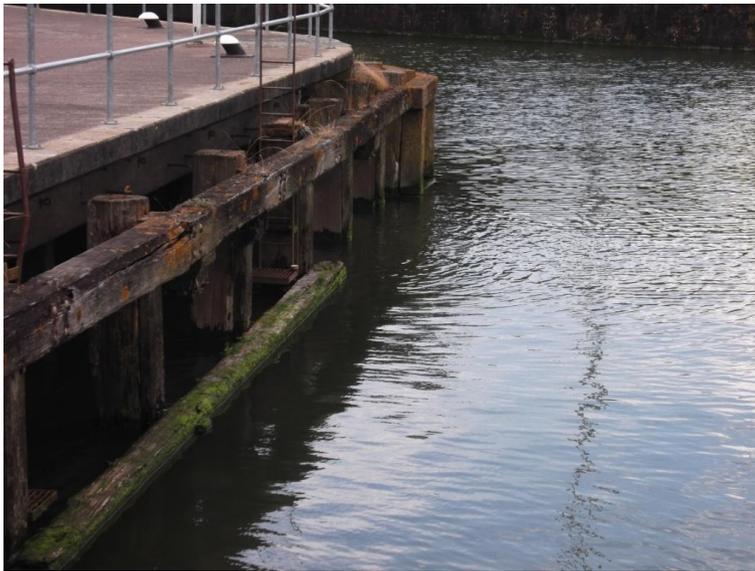
An access pontoon has been installed to remove the need for players to get on via the ladders on the barrier. Paddlers are requested not to use these ladders anymore.
